FRENCH CREEK INSPECTIONS

RESIDENTIAL HOME INSPECTION

1234 Main St. Cary NC 27513

05/11/2022 9:00AM

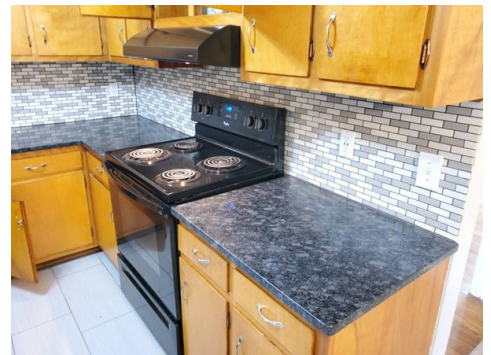
ANTI-TIP: MISSING => SPECIALIST

Condition: The range tilts forward when pressure is applied to the open door.

Recommendation: Refer to qualified contractor for repair.

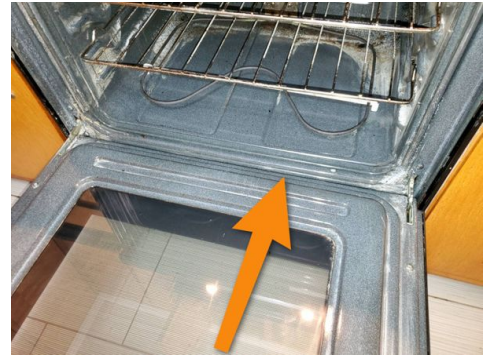
2.2.2 Ranges/Ovens/Cooktops

OVEN: GASKET DAMAGED => SPECIALIST

Condition: The gasket sealing the oven door is damaged or displaced.

Implication: Damaged or ineffective oven gaskets can lead to a number of health and safety problems, as well as wasted energy and improperly cooked food.

Recommendation: Refer to an appliance repair specialist for further evaluation and repair.

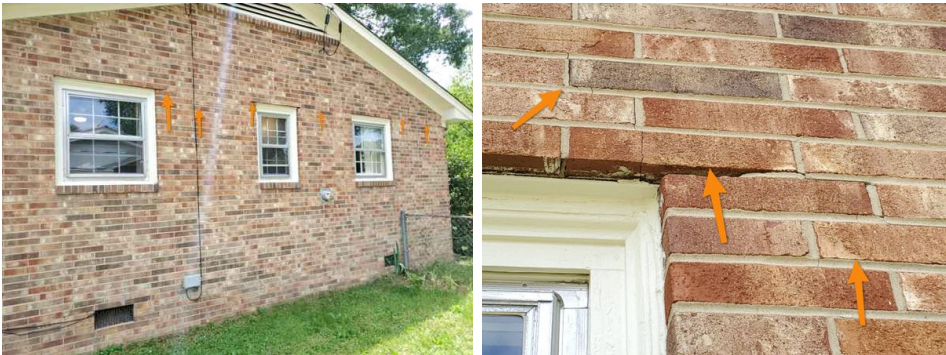
3.4.1 Wall Cladding Brick

CRACK: HORIZONTAL NEAR EAVE => ENGINEER

Condition: A horizontal crack of the brick veneer along the roof eave indicates a problem with installation, the supporting wall structure, or inordinate loading from the roof structure above.

Implication: A horizontal crack of this nature indicates structural deterioration.

Recommendation: Request that the current owner disclose the known history of cracks in the brick veneer with respect to progression, changes with season and repair. Consult an engineer for further assessment of cause and, if necessary, a plan for remediation by a licensed general contractor.

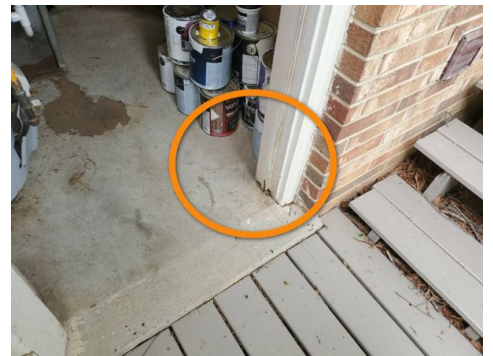
3.7.1 Doors (Exterior)

FRAME: LIGHT DETERIORATION => GC

Condition: The frame of an entry door(s) is deteriorated, decayed or damaged.

Implication: Frame damage will allow water intrusion to and deterioration of the underlying and wall structure.

Recommendation: Inspect all doors for similar damage as repairs are made. Refer to a qualified contractor for evaluation and repair.

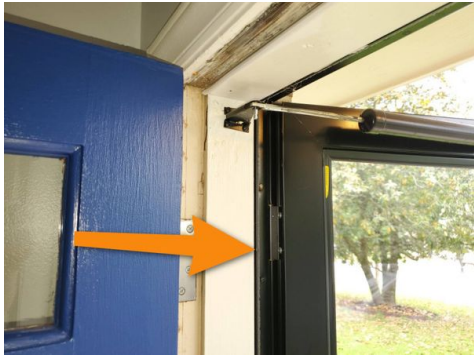
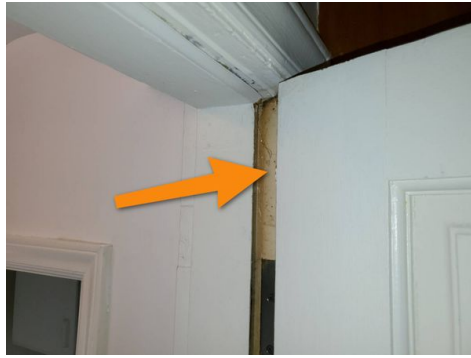
3.7.2 Doors (Exterior)

WEATHER-STRIPPING => SPECIALIST

Condition: The weather-stripping on an entry door(s) is damaged, missing or not forming a tight seal.

Implication: The weather-stripping should be repaired/replaced to ensure that the door closes securely and is weather tight.

Recommendation: Refer to a qualified contractor for repair.

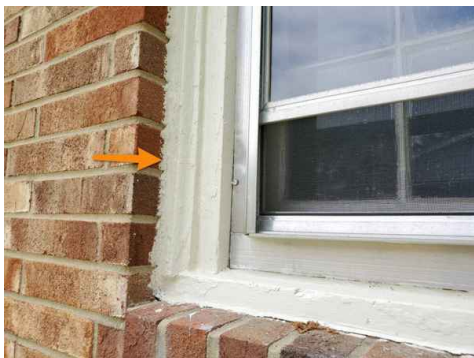
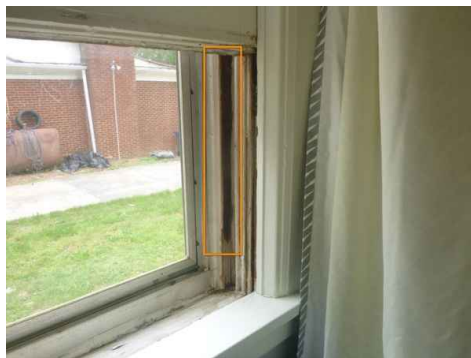
3.8.1 Windows

HEAVILY CAULKED @ BRICK VENEER & DETERIORATION => GC

Condition: The interface between the wood windows and the brick veneer is heavily caulked and there are indications of interior discoloration &/or deterioration.

Implication: The two conditions may indicate water infiltration into and deterioration of the underlying wall structure.

Recommendation: Refer to a licensed general contractor for an invasive inspection of the wall cavity and, if necessary, repair.

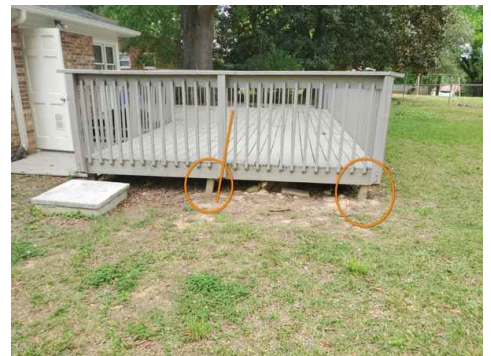
3.9.1 Deck

Condition: A supporting post(s) (pier) is leaning (not "plumb").

Implication: The structure is not properly constructed. Structural failure can result in injury to those using the porch.

Recommendation: Refer to a licensed general contractor for further evaluation and repair.

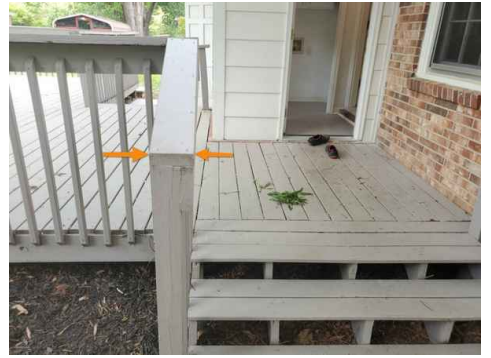
3.9.2 Deck

Condition: A handrail is difficult to grasp. The railing is either too wide, difficult to "hook" from the thumb side or too close to a wall.

Recommendation: Refer to a qualified contractor for repair according to accepted construction practices.

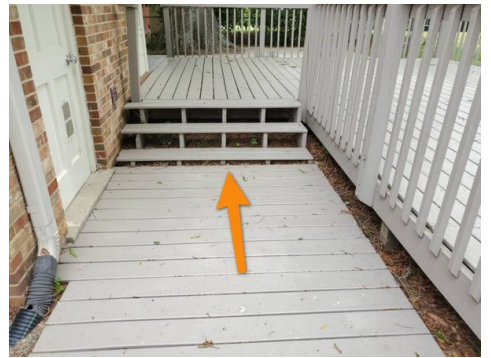
3.9.3 Deck

Condition: The step treads were not consistent or built within typical tolerances.

Implication: The condition could result in a trip hazard.

Recommendation: Refer to a licensed general contractor to evaluate the stair tread heights/depths and make repairs necessary to ensure safe use.

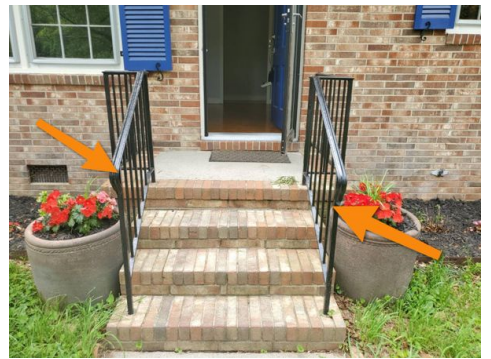
3.10.1 Porches, Steps, Stoops and Applicable Railings

HANDRAIL: LOOSE => SPECIALIST

Condition: A porch handrail(s) is loose and moves freely at a point of attachment.

Implication: Further deterioration will make the porch unsafe.

Recommendation: Refer to a qualified contractor for repair according to accepted construction practices.

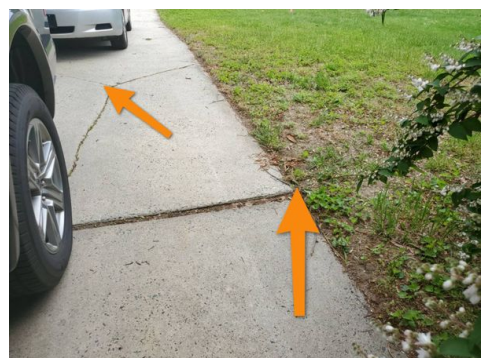
3.12.1 Driveways, Walks and Retaining Walls

CRACKED & DISPLACED => TRIP HAZARD => SPECIALIST

Condition: A driveway or walkway is cracked and displaced, creating a trip hazard.

Implication: Cracked and displaced concrete can create a significant trip hazard.

Recommendation: Refer to a qualified contractor for repair according to accepted construction practices.

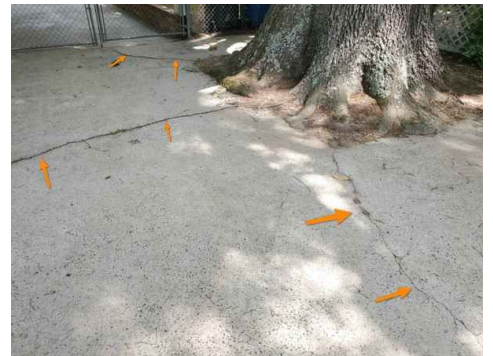
CRACKED & DISPLACED => TRIP HAZARD => SPECIALIST

Condition: The patio is cracked and displaced. The raised section of the driveway has created a path for water penetration under the slab and a trip or fall hazard.

Implication: Continued water infiltration can cause more damage.

Recommendation: Refer to a qualified contractor for further evaluation and repair.

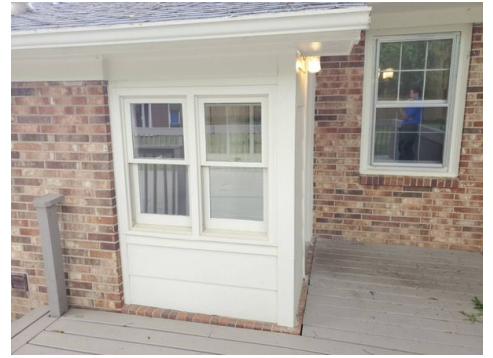
4.1.1 Foundation - Crawlspace

ADDITION OR MAJOR REPAIR: ATYPICAL PERMIT? => SELLER/ENGINEER

Condition: The home includes an addition to the original structure or major repair that was built using atypical construction methods.

Implication: The inspection of the addition or repair with respect to its compliance to building codes or suitability of use is beyond the scope of a home inspection.

Recommendation: The buyer should request that the seller disclose if required building permits were obtained. If permits are not available, consult an engineer to verify that the addition or repair is safe and suitable for use. The seller may also request a permit after the fact, which may involve invasive inspection by the governing municipality.

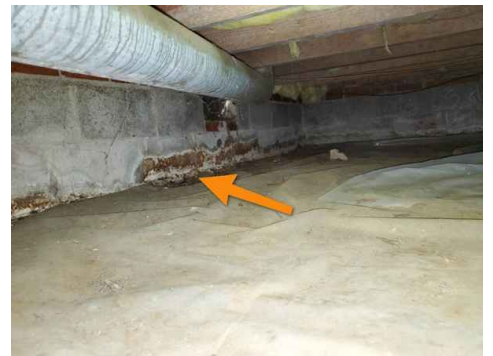
4.1.2 Foundation - Crawlspace

BLOCK: EFFLORESCENCE BUT DRY => GC

Condition: Efflorescence (staining by "salts" migrated from the block interior) indicates the foundation has been wet. The crawl space is protected by a vapor barrier and floor structures do not indicate moisture related deterioration.

Implication: Water penetration into the area beneath floor framing can raise the moisture content of wood components resulting in structural damage and environmental concerns.

Recommendation: For further evaluation, refer to a licensed general contractor experienced in foundation drainage and water proofing for a complete evaluation and to make necessary repairs. Continue to monitor the area for signs of water infiltration and/or moisture related discoloration of framing components.

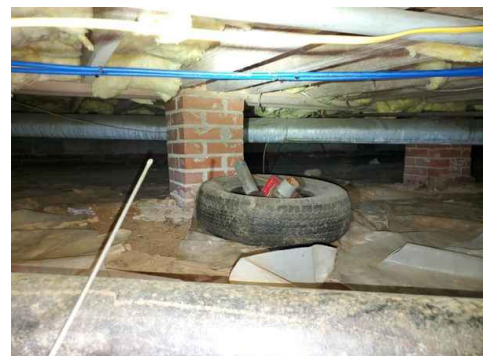
4.1.3 Foundation - Crawlspace

DEBRIS

Condition: The area is littered with debris.

Recommendation: Refer to a specialist to clear out all debris.

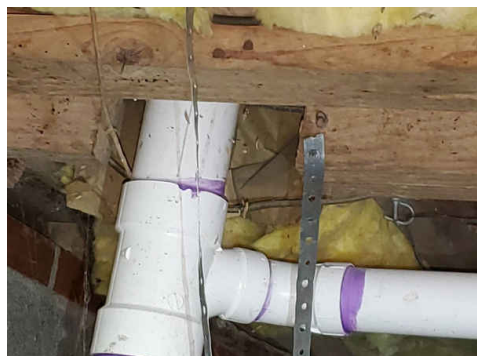
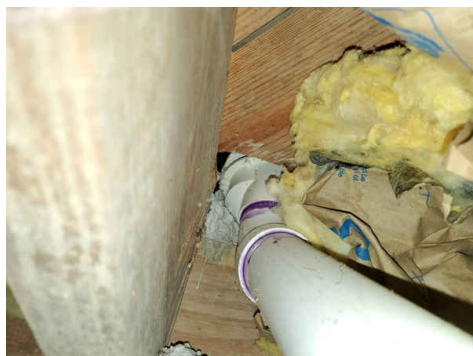
4.3.1 Floor Structure

BEAM: CUT NOTCHED FOR PLUMBING/ELECTRICAL/HVAC => ENGINEER

Condition: A floor beam(s) is cut to allow for installation of plumbing, electrical pipes or HVAC ducts.

Owner's Bath (cut)

Hall Bath (knotched)

Recommendation: Refer to an engineer for further evaluation and, if necessary, to prescribe repairs by a licensed general contractor.

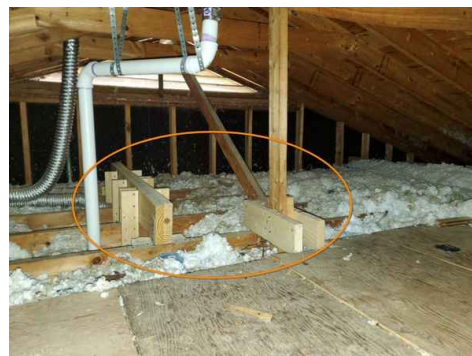
4.5.1 Ceiling Structure

Condition: Structural reinforcement(s) has been added to the ceiling structure.

Implication: The motivation for the repair was not apparent, but structural repairs should be prescribed by a structural engineer.

Recommendation: Ask the seller for more information and, if available, a written report from a structural engineer that prescribes the repair(s). If this is not available, refer to an engineer for further evaluation and, if necessary, to prescribe the proper method of repair by a licensed general contractor.

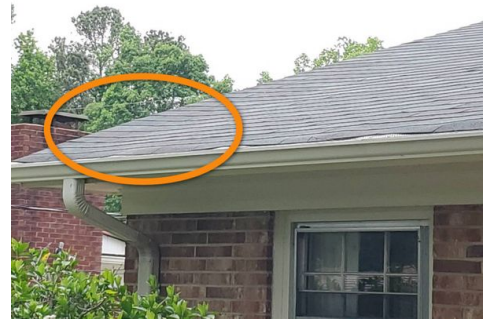
4.6.1 Roof Structure

SHEATHING: ROOF DIP, NO DECAY VIEWED => GC

Condition: There is a noticeable dip in the roof surface.

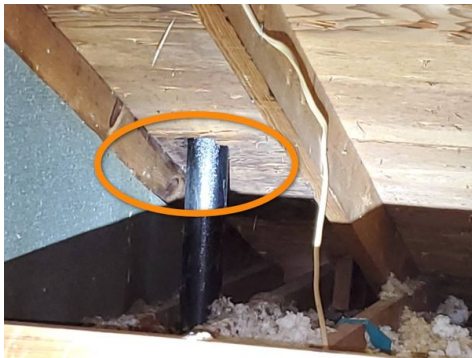
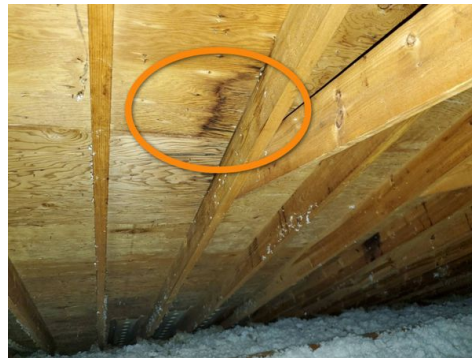
4.6.2 Roof Structure

SHEATHING: WATER STAINS INDICATE LEAK, NO DETERIORATION => ROOFER

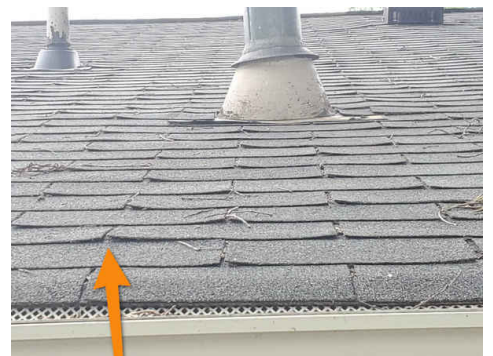
5.1.1 Roof Coverings

Curling

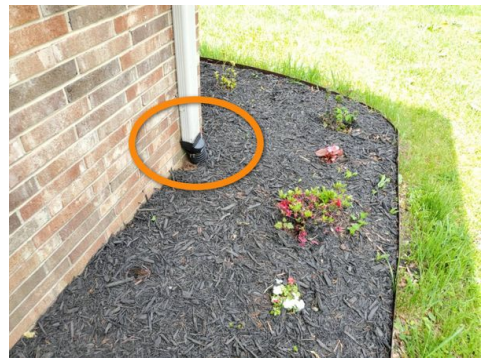
5.2.1 Roof Drainage Systems

EXTENSION: PIPE EXIT? => SPECIALIST

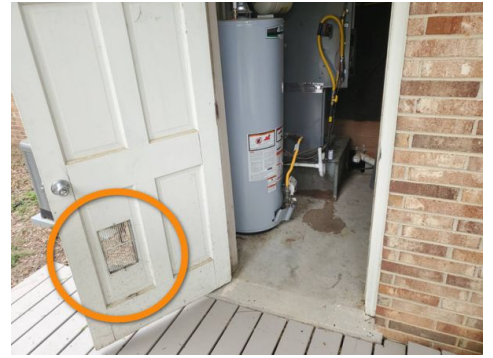
6.6.2 Water Heating

**INSTALLATION: GAS IN CONFINED SPACE
W/LIMITED SOURCE FRESH AIR => PLUMBER**

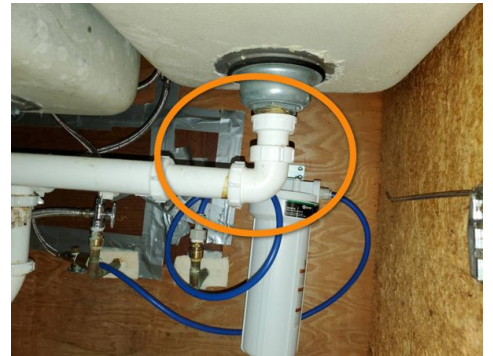
6.8.1 Plumbing Fixtures Sink

DRAIN LEAKING => PLUMBER

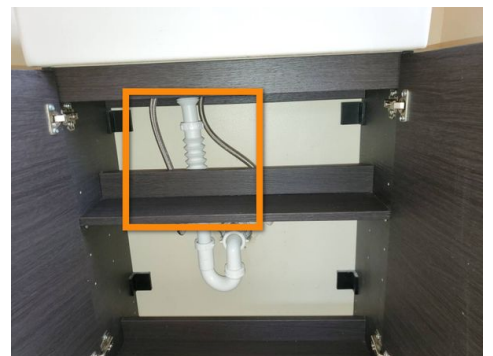
6.8.2 Plumbing Fixtures Sink

TAILPIECE IS FLEXIBLE => PLUMBER

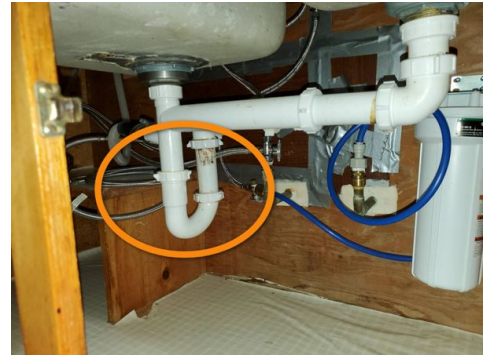
6.8.3 Plumbing Fixtures Sink

TRAP TOO DEEP => PLUMBER

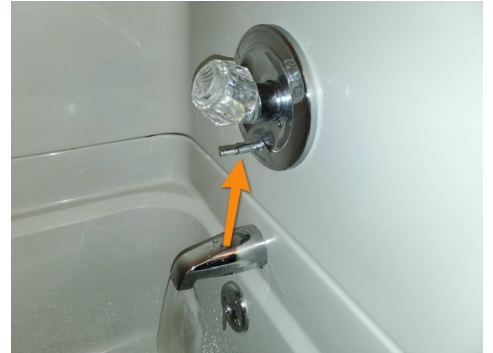
6.9.1 Plumbing Fixtures Shower

SHOWER: DIVERTER LEAKING => PLUMBER

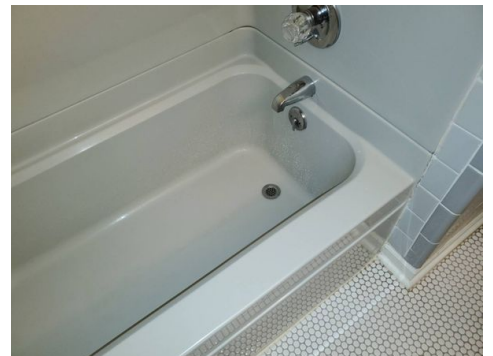
6.10.1 Plumbing Fixtures Tub

TUB: DRAIN SLOW => PLUMBER

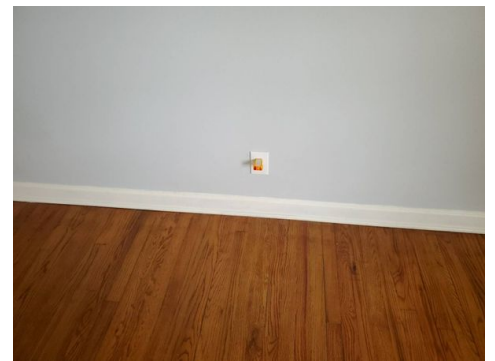
7.4.1 Branch Circuits

2-WIRE: RECEPTACLE W/3-PRONG, BUT NO GFCI PROTECTION => ELECTRICIAN

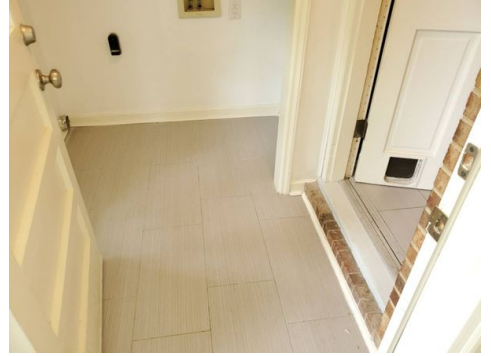
9.2.3 HVAC Distribution

UNHEATED INTERIOR => HVAC

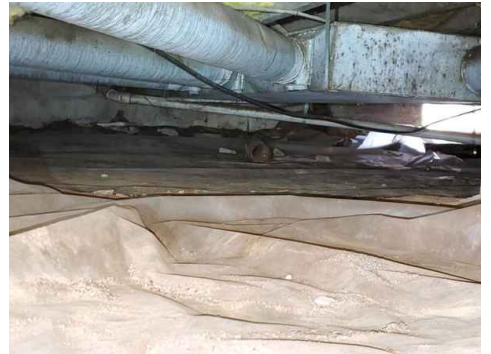
9.2.4 HVAC Distribution

**ROUND METAL DUCTS => INSULATION
CONDENSATION => HVAC**

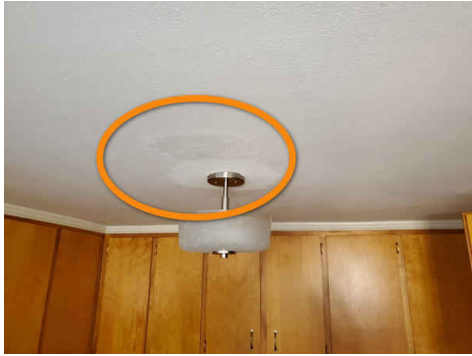
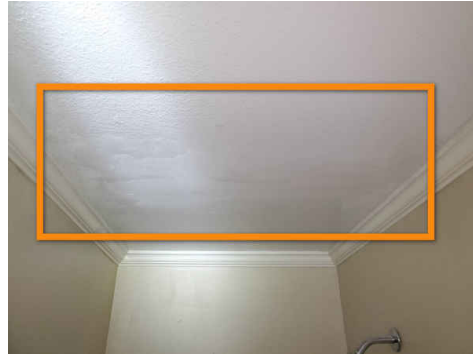
11.1.2 Interior General

CEILING: REPAIR - WHY?=> GC

Kitchen

Owner's Bath
