FRENCH CREEK INSPECTIONS

RESIDENTIAL HOME INSPECTION

1234 Main St. Cary NC 27513

05/11/2022 9:00AM

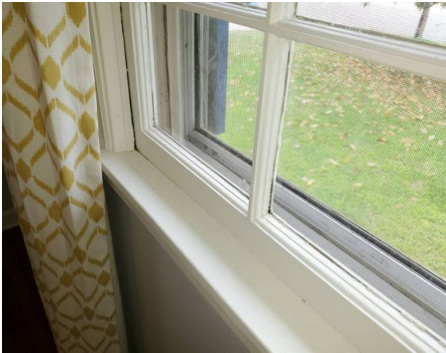
Windows: Advisory: Single Pane

Advisory: Most windows today have two panes of glass and the space between is vacuum sealed with an inert gas to improve energy efficiency. Windows in this home have a single pane and are less energy efficient.

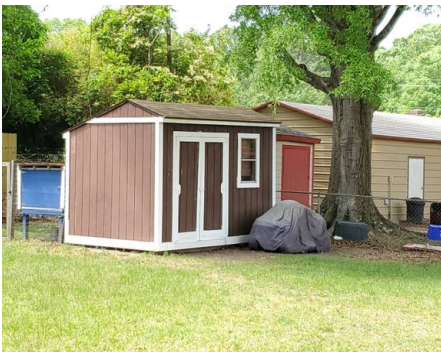
Detached Building Exterior: Advisory: Detached Not Inspected

Advisory: The detached building(s) was not included in the inspection.

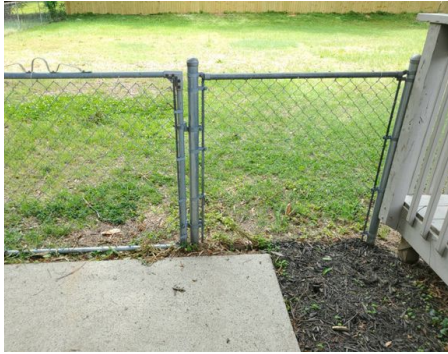
Fence: Advisory: Fence Not SOP

Advisory: Inspection of exterior fences are outside the scope of the NC standard of practice. Refer to a specialist to assess the fence condition and cost of repair.

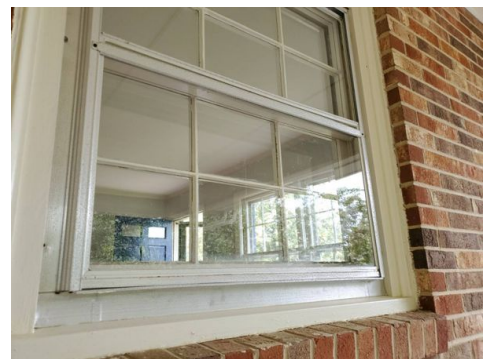
LIMITATION: STORM WINDOWS AND DOORS NOT INCLUDED

Limitation: The windows are covered with storm windows which greatly limit inspection of the exterior of the exterior window sash and frame.

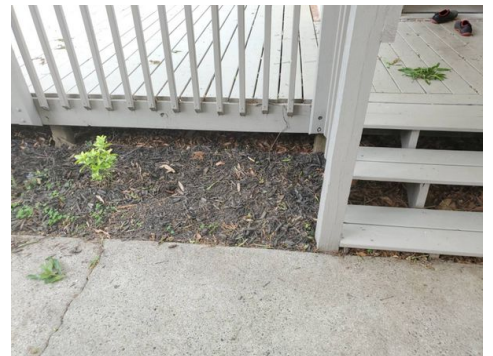
REAR

LIMITATION: LOW HEIGHT AND OR APRON

Limitation: The porch low height above grade, decorative apron or both prohibit or greatly limit inspection of the deck's structure, flashing and attachment to the house. A more thorough inspection will require an invasive inspection by a licensed general contractor for .

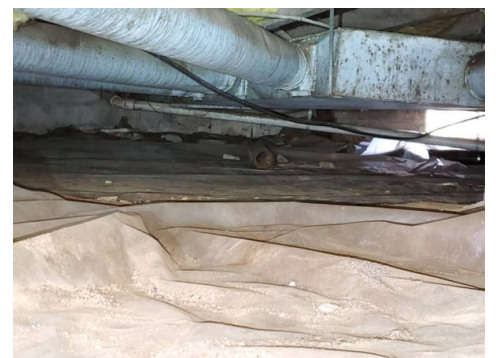
BENEATH KITCHEN

Limitation: Due to low clearance, obstruction by HVAC ductwork
and/or or plumbing, inspection of the foundation, floor structure,
insulation and mechanical systems was limited.

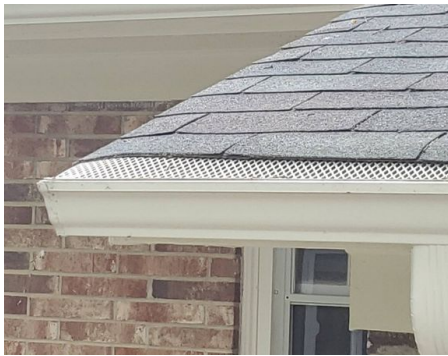
Roof Drainage Systems: Advisory: Gutter Guard - Warranty?

Advisory: The roof drainage system is protected from clogging by a gutter guard. These systems sometimes come with a transferable warranty. Ask the seller for information regarding the installation.

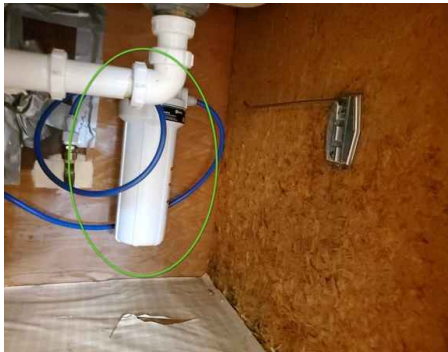
A sediment filter acts as a sieve to remove these particles. They don't remove chemicals or heavy metals or make the water taste or smell better.

The filter requires regular maintenance.

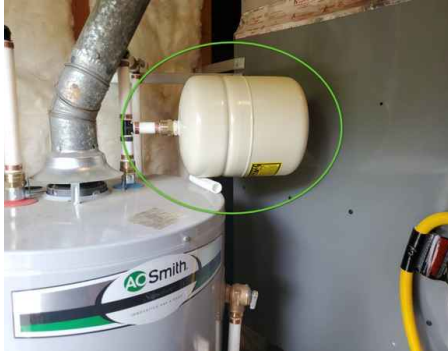
Maintenance Advisory: Expansion tanks are safety devices meant to prevent the water heating unit from exploding and have been recommended since 2002. The hot water system for this home does have an expansion tank. These tanks are prone to fail more often than the water heater and should be tested routinely. The common way to test the expansion tank is to rap it with a metal object on both ends. Since a portion of the tank should hold water, the sound from the end closest to the water heater should be dull. The other end should be holding air and should sound like a "ting". If the tank appears to have failed, refer to a licensed plumbing contractor for repair.

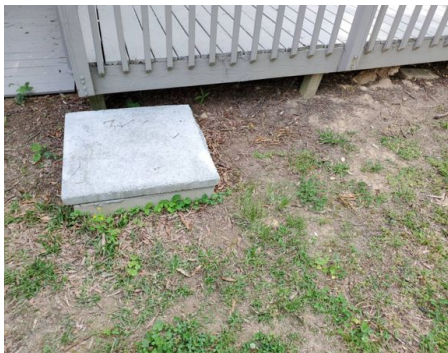
Private Septic System: Advisory

Advisory: A private septic system disposes plumbing waste. It is the homeowner's responsibility to operate and maintain this systems, but determining their adequacy is beyond the scope of the home inspection. The buyer (homeowner) should consult the local health department or a licensed septic contractor for evaluation of the system.

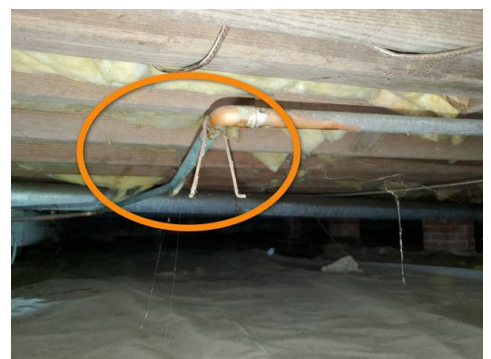
6.3.1 Water Distribution

Contact a qualified plumbing contractor.

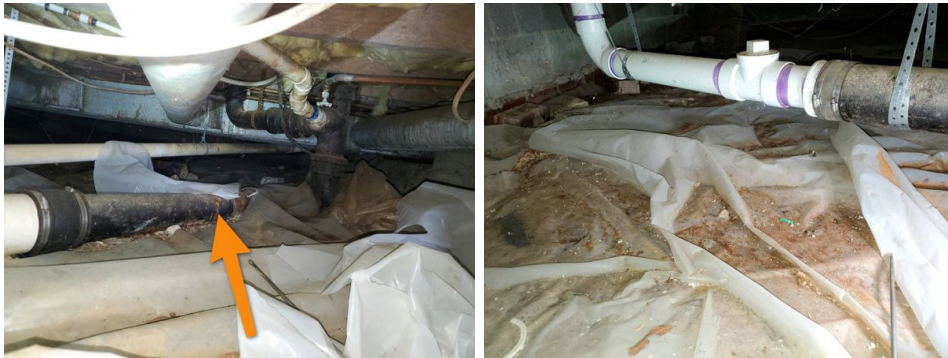
- ⊖ 6.3.1 Plumbing - Water Distribution: Support: Inadequate => Plumber
- ⊖
- ⊖ 6.4.1 Plumbing - Plumbing Drain and Waste: Main and Branch: Cast Iron with Visible Corrosion &/or Leaking => Plumber

6.4.1 Plumbing Drain and Waste

Contact a qualified plumbing contractor.

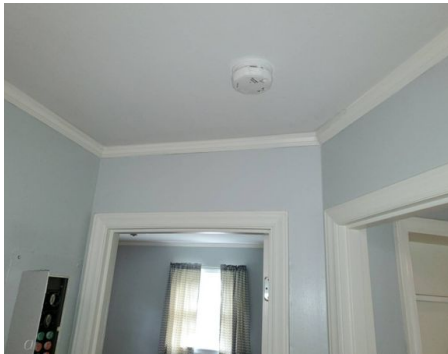
Smoke Detectors: Advisory: Smoke Battery Only

Advisory: The smoke detector(s) relies on battery only and is not connected to house power. This makes it especially important to change the batteries semi-annually. Ideally, smoke detectors should be added to bedrooms and interconnected with hallway smoke and CO detectors to sound concurrently.

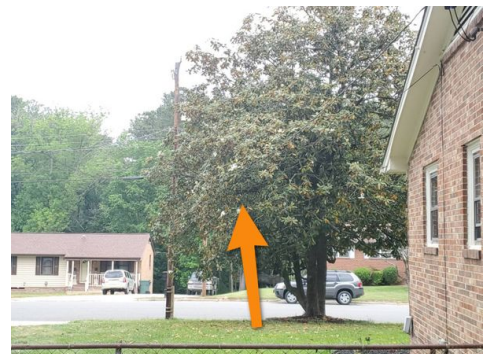
7.1.1 Service Entrance Conductors

Contact your local utility company

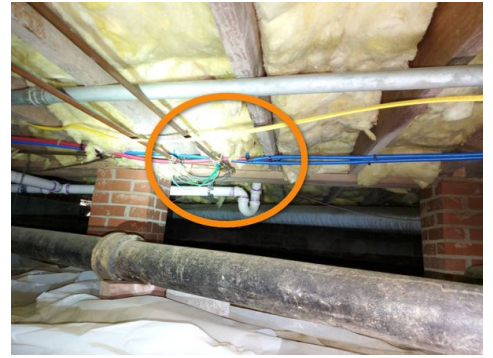
7.2.1 Service and Grounding Equipment

Contact a qualified electrical contractor.

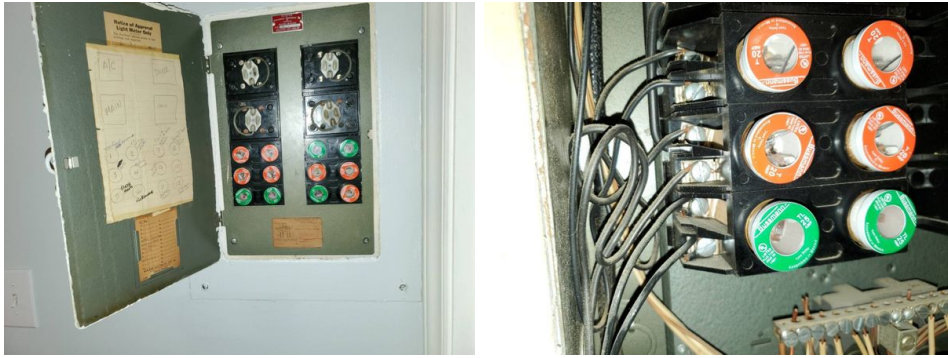
7.2.2 Service and Grounding Equipment

Contact a qualified electrical contractor.

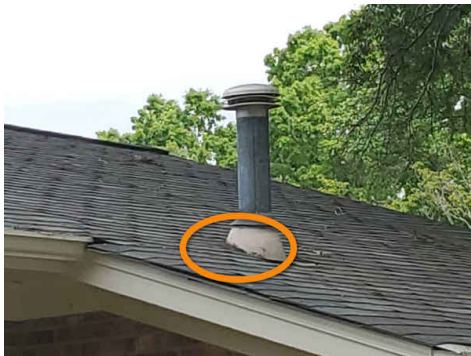
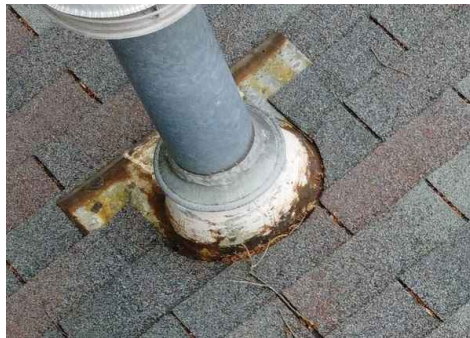
Furnace Flue

9.1.2 Split System Heating - Heating Equipment: Metal Flue: Repaired => HVAC

Contact a qualified heating and cooling contractor

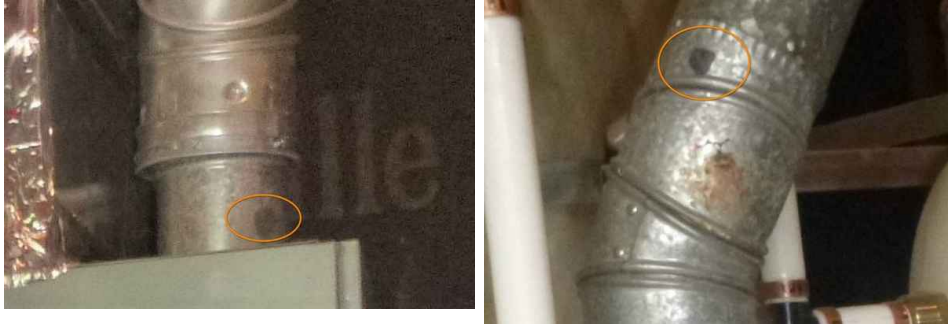
9.2.1 HVAC Distribution

Contact a qualified professional.

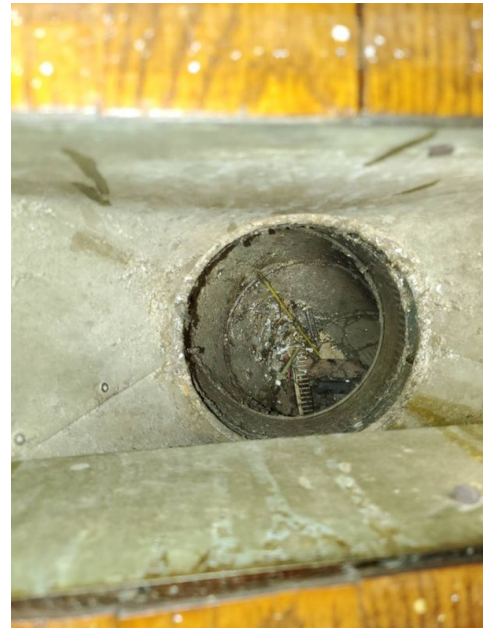
9.2.2 Split System Heating - HVAC Distribution: Metal Duct or Distribution Corroded

9.2.2 HVAC Distribution

Contact a qualified HVAC professional.

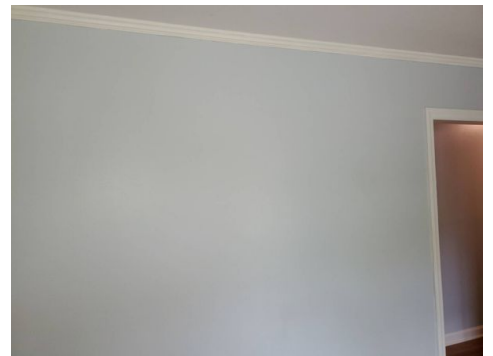
FRESHLY PAINTED

Limitation: The interior of the home has been recently painted. Cracks indicating structural concerns, stains indicating water intrusion and other concerns may not be visible.

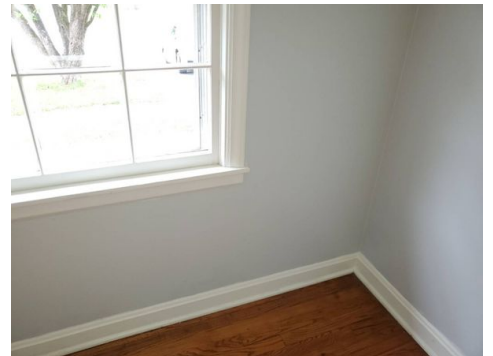
11.1.1 Interior General

Contact a qualified professional.
